Surveyor Name	GCK	Certificate Number	U-210-10171
Owner		Customer	
Drainage Area		PO Number	1-1618
Pipe Segment Reference	TC4-M5-16 to TC4-M5-17	Date	7/29/2022 11:53
Street	Midgard	City	POSMville
Comments

Upstream MH	TC4-M5-16	Rim to Invert (U)	
Grade to Invert (U)		Rim to Grade (U)	
Downstream MH	TC4-M5-17	Rim to Invert (D)	
Grade to Invert (D)		Rim to Grade (D)	
Pipe Use	Sanitary Sewage Pipe	Direction of Survey	Downstream

Height (Diameter)	8	Width	
Shape	Circular	Material	Vitrified Clay Pipe
Lining Method		Pipe Joint Length	
Total Length		Length Surveyed	304.2
Year Constructed		Year Renewed

Flow Control		Media Label	6/19/09
Purpose	Pre-Rehabilitation Survey	Consequence of Failure	
Pre-Cleaning	Heavy Cleaning	Date Cleaned	7/29/2022 11:53
Weather	Light Rain	Location Code	Easement/Right of Way
Additional Info		Location Details

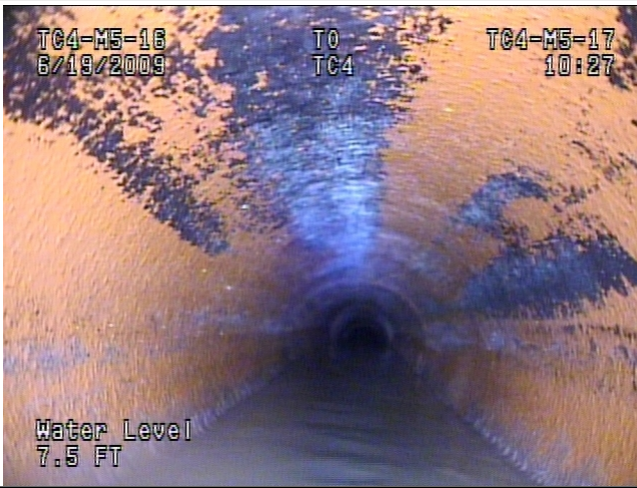
7.5	Miscellaneous Water Level Severity: None Defect: 0 Percent: 10	00:00:44

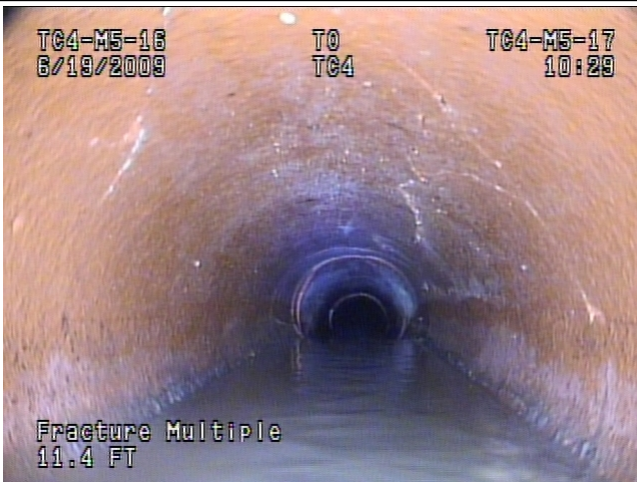
11.4	Fracture Multiple Position: 12 To 1 Severity: None Cont Defect: S01 Defect: 0 Percent: 0 Joint Remarks: N/L Struct Weight: 4	00:01:56

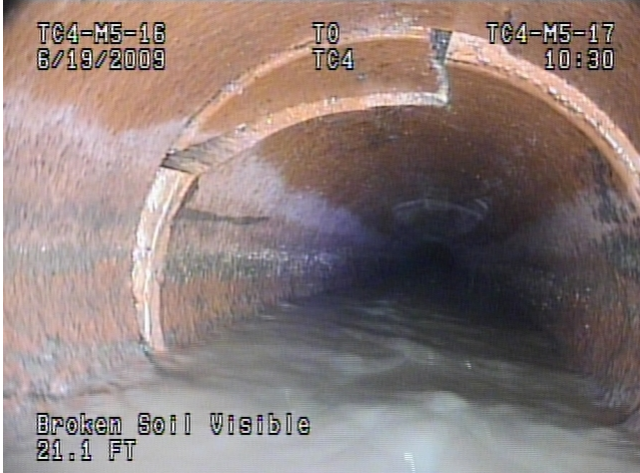
Distance	Fault Observation	Time	Picture
21.1	Broken Soil Visible Position: 9 To 1 Severity: None Defect: 0 Percent: 0 Joint Struct Weight: 5	00:03:46

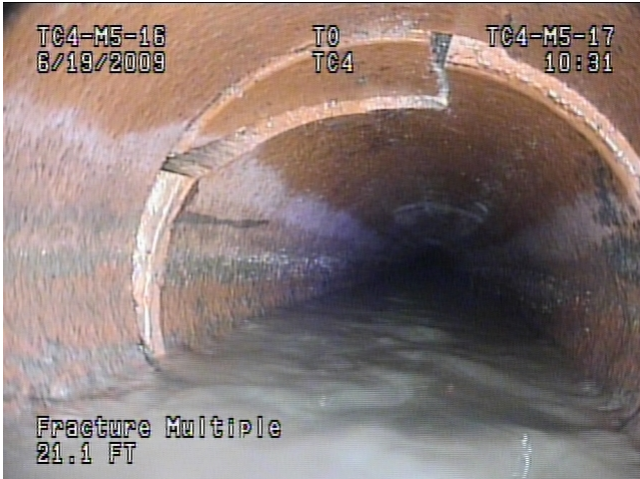
<p>TC4-M5-16 6/19/2009 TO TC4 TC4-M5-17 10:30</p> <p>Broken Soil Visible 21.1 FT</p>
21.1	Fracture Multiple Position: 12 To 1 Severity: None Cont Defect: F01 Defect: 0 Percent: 0 Joint Remarks: N/L Struct Weight: 4	00:04:02

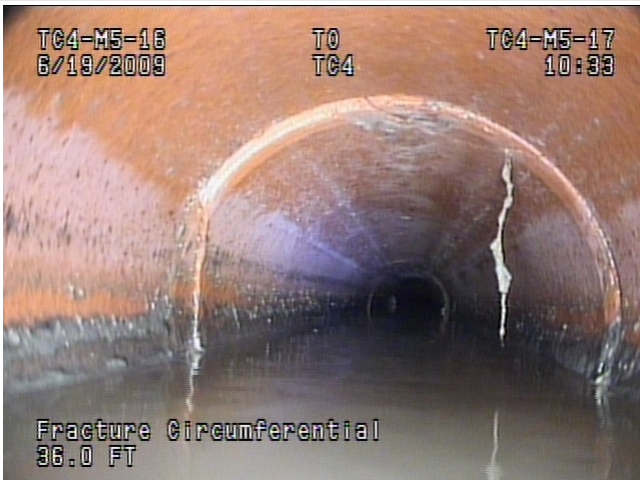
<p>TC4-M5-16 6/19/2009 TO TC4 TC4-M5-17 10:31</p> <p>Fracture Multiple 21.1 FT</p>
36.0	Fracture Circumferential Position: 12 To 1 Severity: None Defect: 0 Percent: 0 Joint Remarks: N/L Struct Weight: 2	00:06:48

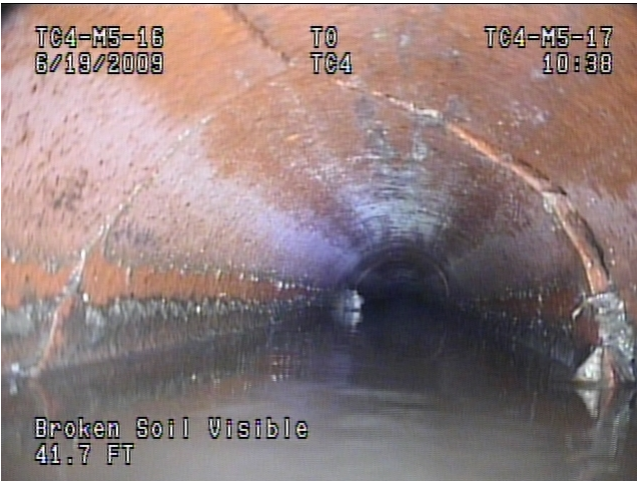
Distance	Fault Observation	Time	Picture
41.7	Broken Soil Visible Position: 12 To 1 Severity: None Defect: 0 Percent: 0 Struct Weight: 5	00:11:50

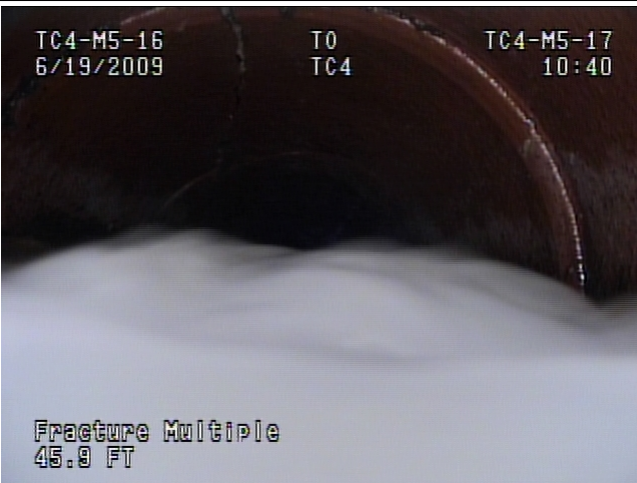
45.9	Fracture Multiple Position: 12 To 1 Severity: None Defect: 0 Percent: 0 Joint Struct Weight: 4	00:12:57

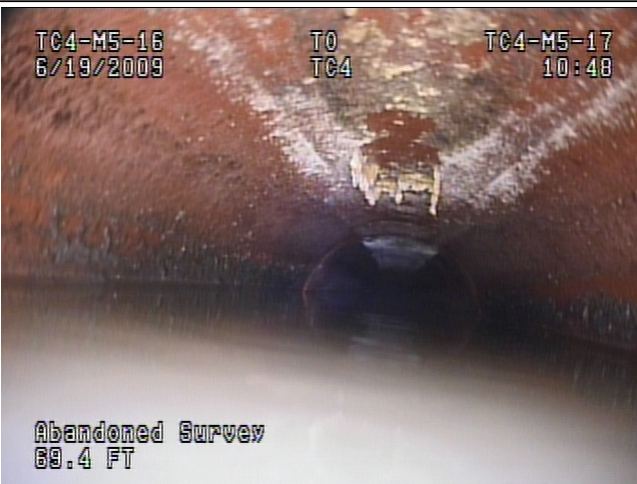
69.4	Miscellaneous Abandoned Survey Severity: None Defect: 0 Percent: 0 Remarks: NEEDS JETTING	00:21:07

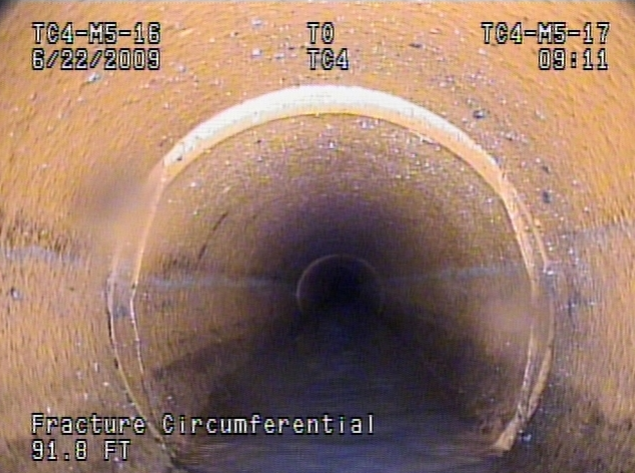
Distance	Fault Observation	Time	Picture
91.8	Fracture Circumferential Position: 2 To 1 Severity: None Defect: 0 Percent: 0 Joint Struct Weight: 2	00:29:55

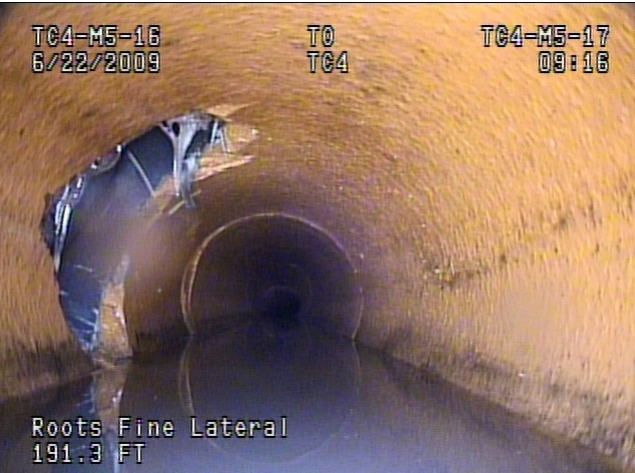
<p>TC4-M5-16 6/22/2009 TO TC4 TC4-M5-17 09:11</p> <p>Fracture Circumferential 91.8 FT</p>
191.3	Roots Fine Lateral Position: 9 Severity: None Defect: 0 Percent: 0 Maint Weight: 1	00:35:06

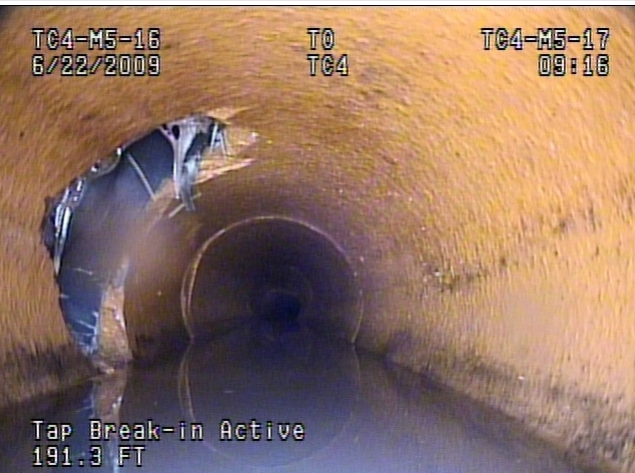
<p>TC4-M5-16 6/22/2009 TO TC4 TC4-M5-17 09:16</p> <p>Roots Fine Lateral 191.3 FT</p>
191.3	Tap Break-in Activity Position: 8 Severity: None Size: 6 Defect: 0 Percent: 0	00:34:47

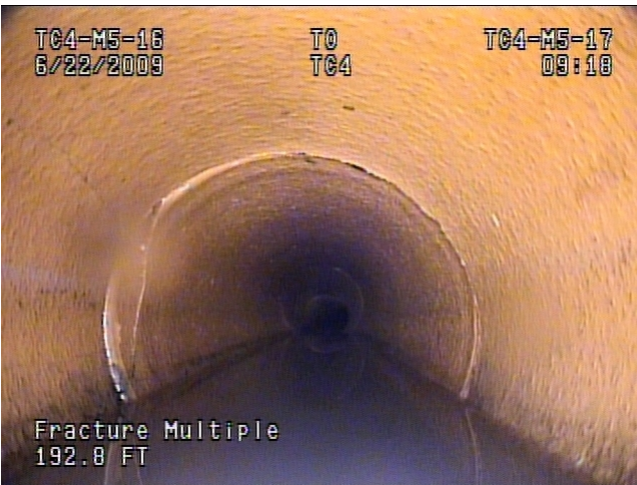
Distance	Fault Observation	Time	Picture
192.8	Fracture Multiple Position: 7 To 1 Severity: None Defect: 0 Percent: 0 Joint Struct Weight: 4	00:36:33

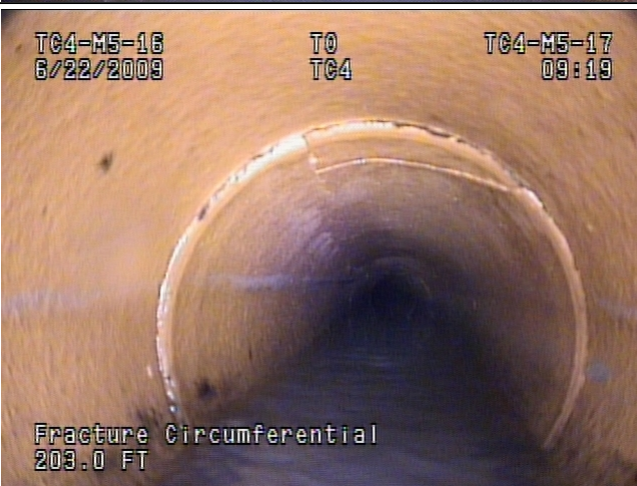
203.0	Fracture Circumferential Position: 11 To 2 Severity: None Defect: 0 Percent: 0 Joint Struct Weight: 2	00:38:08

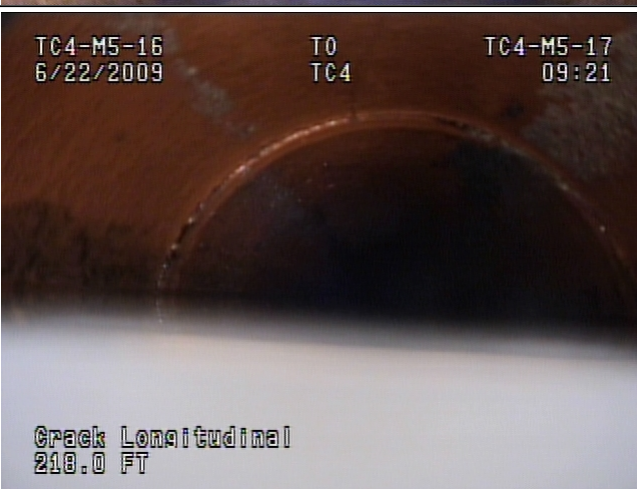
218.0	Crack Longitudinal Position: 12 Severity: None Defect: 0 Percent: 0 Joint Struct Weight: 2	00:39:29

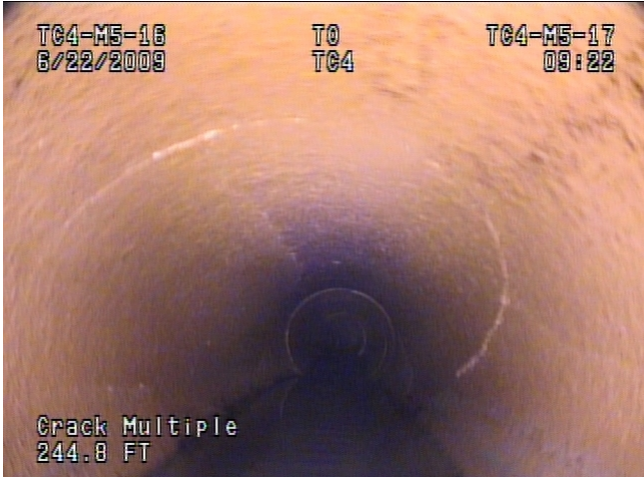
Distance	Fault Observation	Time	Picture
244.8	Crack Multiple Position: 12 To 1 Severity: None Cont Defect: S02 Defect: 0 Percent: 0 Joint Struct Weight: 3	00:41:25

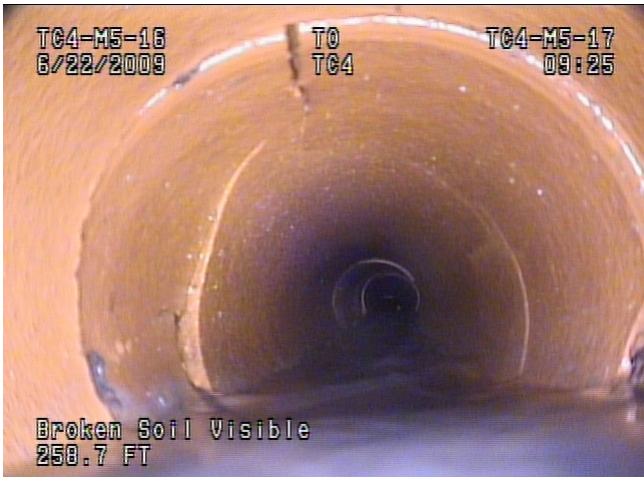
<p>TC4-M5-16 6/22/2009</p> <p>T0 TC4</p> <p>TC4-M5-17 09:22</p> <p>Crack Multiple 244.8 FT</p>
258.7	Broken Soil Visible Position: 12 To 1 Severity: None Defect: 0 Percent: 0 Joint Struct Weight: 5	00:44:03

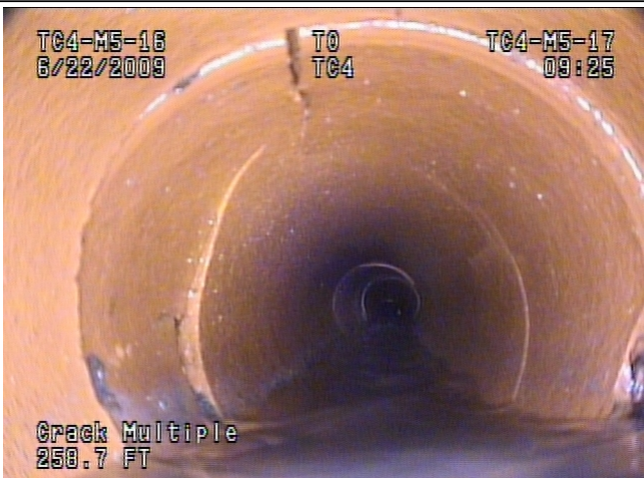
<p>TC4-M5-16 6/22/2009</p> <p>T0 TC4</p> <p>TC4-M5-17 09:25</p> <p>Broken Soil Visible 258.7 FT</p>
258.7	Crack Multiple Position: 12 To 1 Severity: None Cont Defect: F02 Defect: 0 Percent: 0 Joint Struct Weight: 3	00:43:34

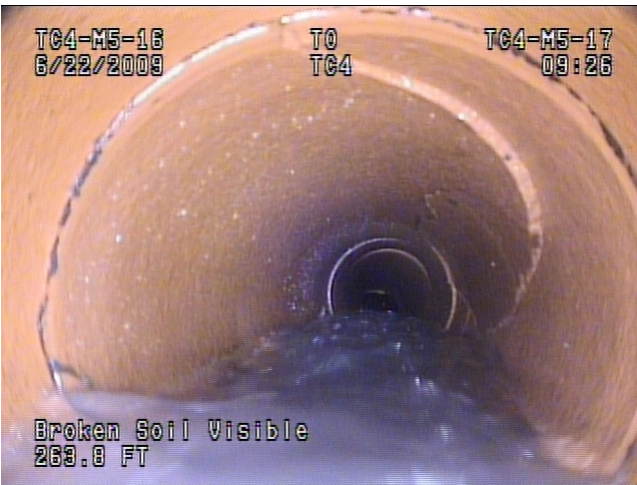
Distance	Fault Observation	Time	Picture
263.8	Broken Soil Visible Position: 12 To 1 Severity: None Cont Defect: S03 Defect: 0 Percent: 0 Joint Struct Weight: 5	00:45:23

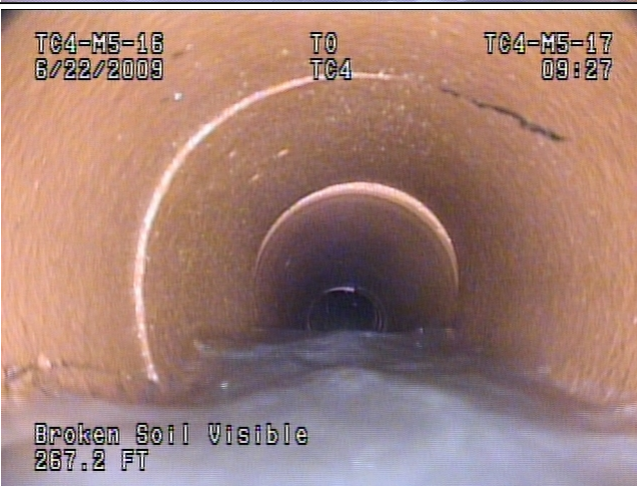
267.2	Broken Soil Visible Position: 12 To 1 Severity: None Cont Defect: F03 Defect: 0 Percent: 0 Joint Struct Weight: 5	00:46:08

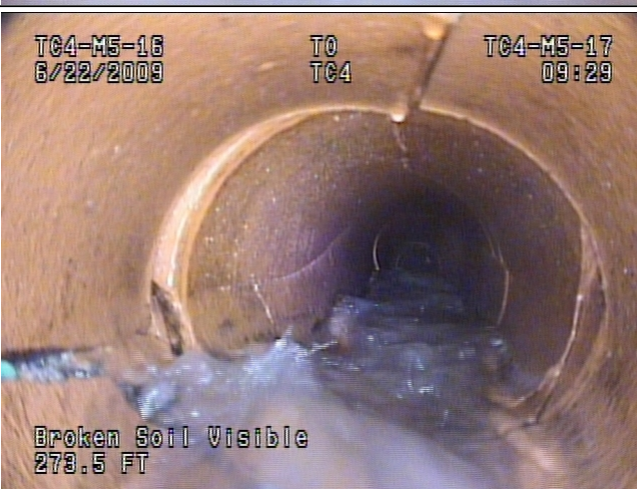
273.5	Broken Soil Visible Position: 12 To 1 Severity: None Cont Defect: S04 Defect: 0 Percent: 0 Joint Struct Weight: 5	00:47:38

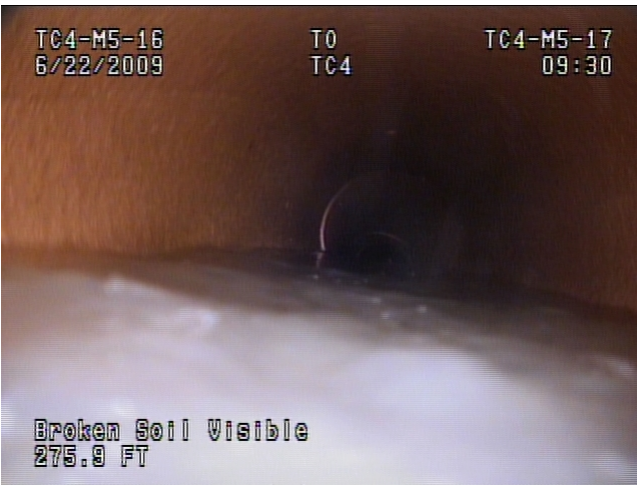
Distance	Fault Observation	Time	Picture
275.9	Broken Soil Visible Position: 12 To 1 Severity: None Cont Defect: F04 Defect: 0 Percent: 0 Joint Struct Weight: 5	00:48:29

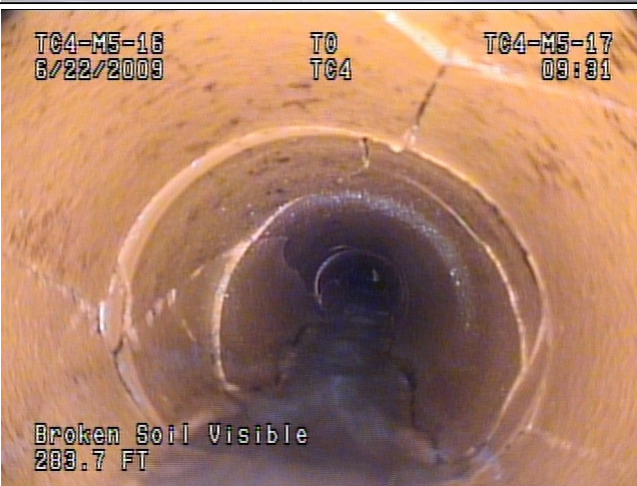
283.7	Broken Soil Visible Position: 12 To 1 Severity: None Cont Defect: S05 Defect: 0 Percent: 0 Joint Struct Weight: 5	00:49:57

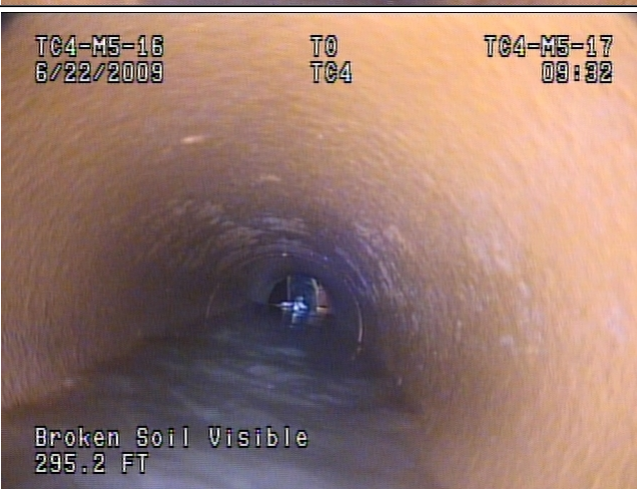
295.2	Broken Soil Visible Position: 12 To 1 Severity: None Cont Defect: F05 Defect: 0 Percent: 0 Joint Struct Weight: 5	00:50:45

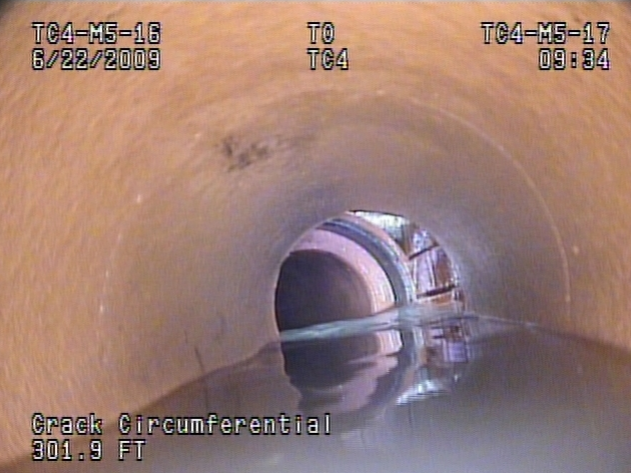
Distance	Fault Observation	Time	Picture
301.9	Crack Circumferential Position: 12 To 1 Severity: None Defect: 0 Percent: 0 Struct Weight: 1	00:52:53
