Surveyor Name	GCK	Certificate Number	U-210-10171
Owner		Customer	
Drainage Area		PO Number	1-1618
Pipe Segment Reference	TC4-M5-16 to TC4-M5-17	Date	7/29/2022 11:53
Street	Midgard	City	POSMville
Comments

Upstream MH	TC4-M5-16	Rim to Invert (U)	
Grade to Invert (U)		Rim to Grade (U)	
Downstream MH	TC4-M5-17	Rim to Invert (D)	
Grade to Invert (D)		Rim to Grade (D)	
Pipe Use	Sanitary Sewage Pipe	Direction of Survey	Downstream

Height (Diameter)	8	Width	
Shape	Circular	Material	Vitrified Clay Pipe
Lining Method		Pipe Joint Length	
Total Length		Length Surveyed	304.2
Year Constructed		Year Renewed

Flow Control		Media Label	6/19/09
Purpose	Pre-Rehabilitation Survey	Consequence of Failure	
Pre-Cleaning	Heavy Cleaning	Date Cleaned	7/29/2022 11:53
Weather	Light Rain	Location Code	Easement/Right of Way
Additional Info		Location Details

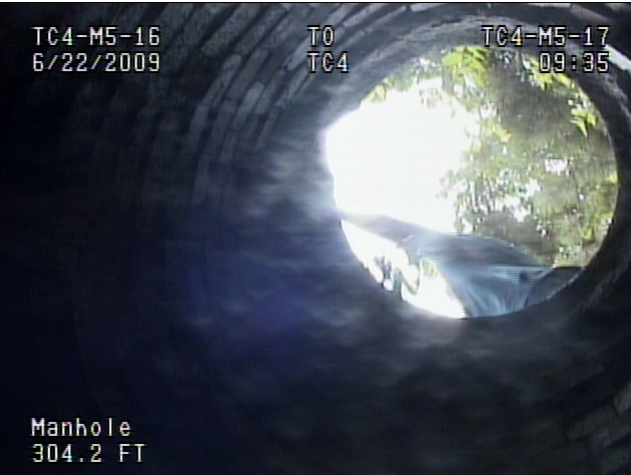
304.2	Access Point Manhole Severity: None Defect: 0 Percent: 0 Remarks: TC4-M5-17	00:53:32

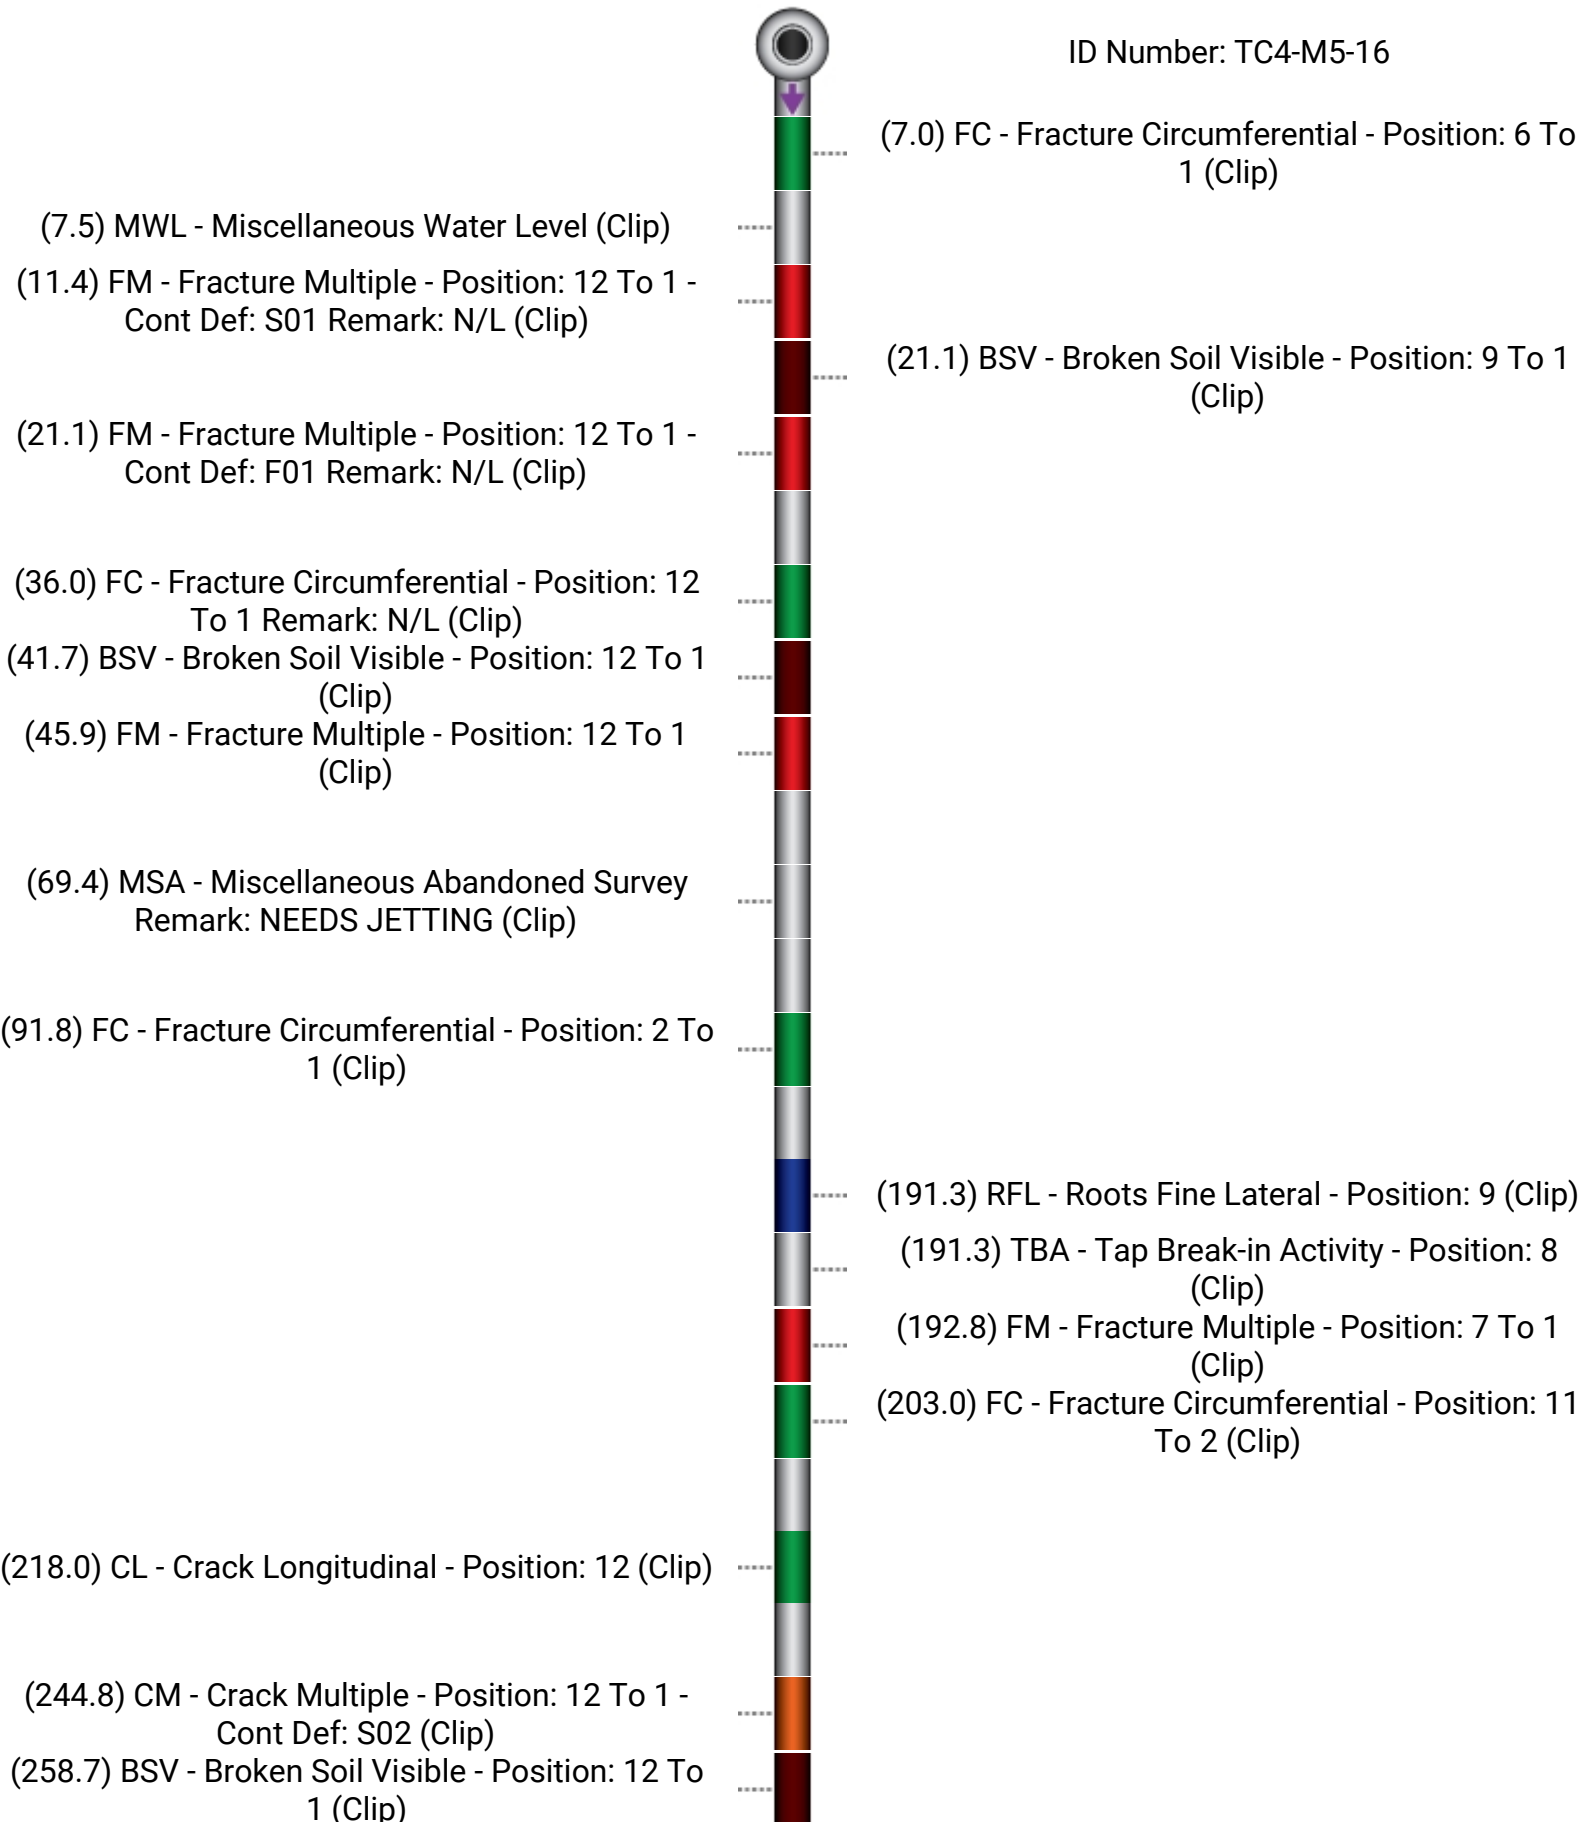
ID Number: TC4-M5-16

- (258.7) CM - Crack Multiple - Position: 12 To 1 - Cont Def: F02 (Clip)
- (263.8) BSV - Broken Soil Visible - Position: 12 To 1 - Cont Def: S03 (Clip)
- (267.2) BSV - Broken Soil Visible - Position: 12 To 1 - Cont Def: F03 (Clip)
- (273.5) BSV - Broken Soil Visible - Position: 12 To 1 - Cont Def: S04 (Clip)
- (275.9) BSV - Broken Soil Visible - Position: 12 To 1 - Cont Def: F04 (Clip)
- (283.7) BSV - Broken Soil Visible - Position: 12 To 1 - Cont Def: S05 (Clip)
- (295.2) BSV - Broken Soil Visible - Position: 12 To 1 - Cont Def: F05 (Clip)
- (301.9) CC - Crack Circumferential - Position: 12 To 1 (Clip)
- (304.2) AMH - Access Point Manhole Remark: TC4-M5-17 (Clip)
